PROPERTY SURVEY REPORT

Town Project RFP 20-07
Survey and Wetland Delineation for
High Meadows Property
825 Hartford Turnpike
Hamden, CT

Prepared for :
Town of Hamden, Connecticut

Prepared by:
Martinez Couch and Associates, LLC

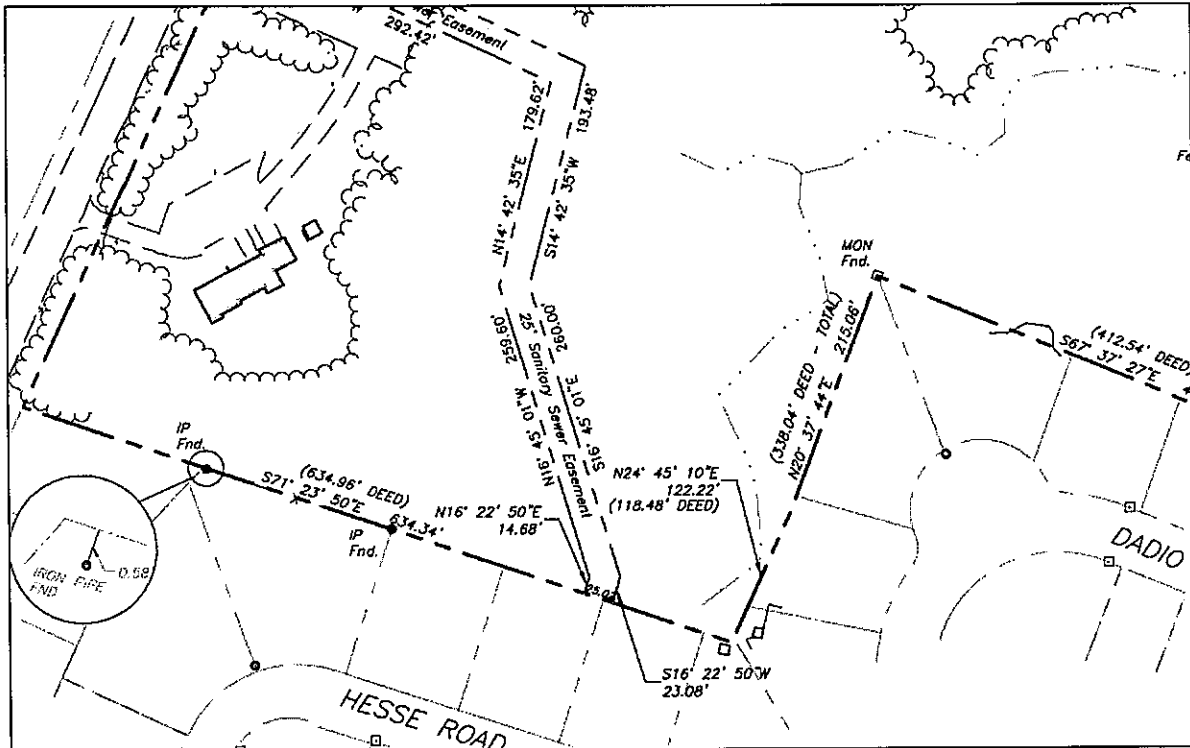
Image 2: Map Image Corner of Dadio and Hesse Road

When reconciling the field evidence found on Daddio Road (*Reference Map #5 Forest Hills Section 3 Subdivision*) and Hesse Road (*Reference Map #2: Forest Hills Section 1*), the field evidence (monuments, Iron pins and other markers) for the roads and the individual lots did not agree with dimensions shown on the subdivision maps. In forming an opinion on the location of the subject parcel on southeast corner, the "best fit" method was used, holding the direction and distances from the original unrecorded map provided by the State of Connecticut Representative on site (above) and from the legal description on the deed. (*Deed Volume 296 Page 219*)
